Solaris MkIII - Design and Goals

Solaris MkIII - Performance and Learnings

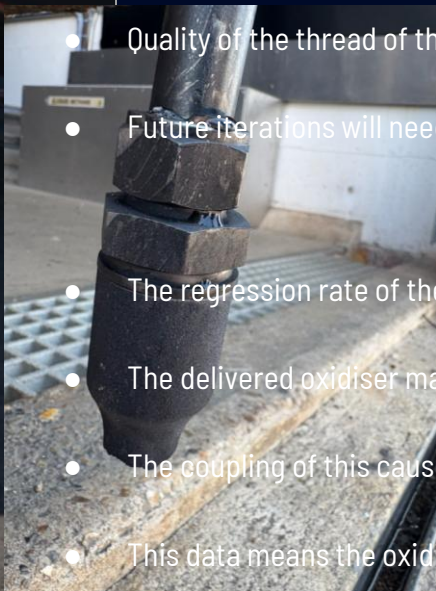
Aft closure thread failure

- The team does the entirety of its manufacturing in house

- Quality of the thread of the chamber coupler was below specification and thus sheared under load

- Future iterations will need thread micrometres or 3 pin method checks to ensure mating parts are within tolerance

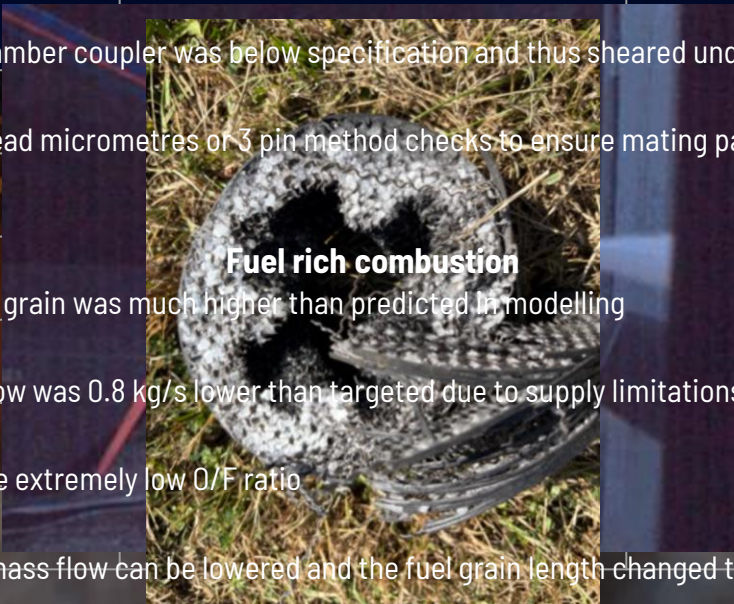
(bar)

- The regression rate of the fuel grain was much higher than predicted in modelling

- The delivered oxidiser mass flow was 0.8 kg/s lower than targeted due to supply limitations

- The coupling of this caused the extremely low O/F ratio

- This data means the oxidiser mass flow can be lowered and the fuel grain length changed to achieve the target thrust
